WUR GREENHOUSE HORTICULTURE INSPECTION REPORT

Test number: 2017-904
Subject: Pipe paint coating
Type: PIPE PAINT H51 SB
Submitted by: Mr G. Geraerts, Spuiterij Geraerts, Ambachten 10, 5711LC Someren (NL)

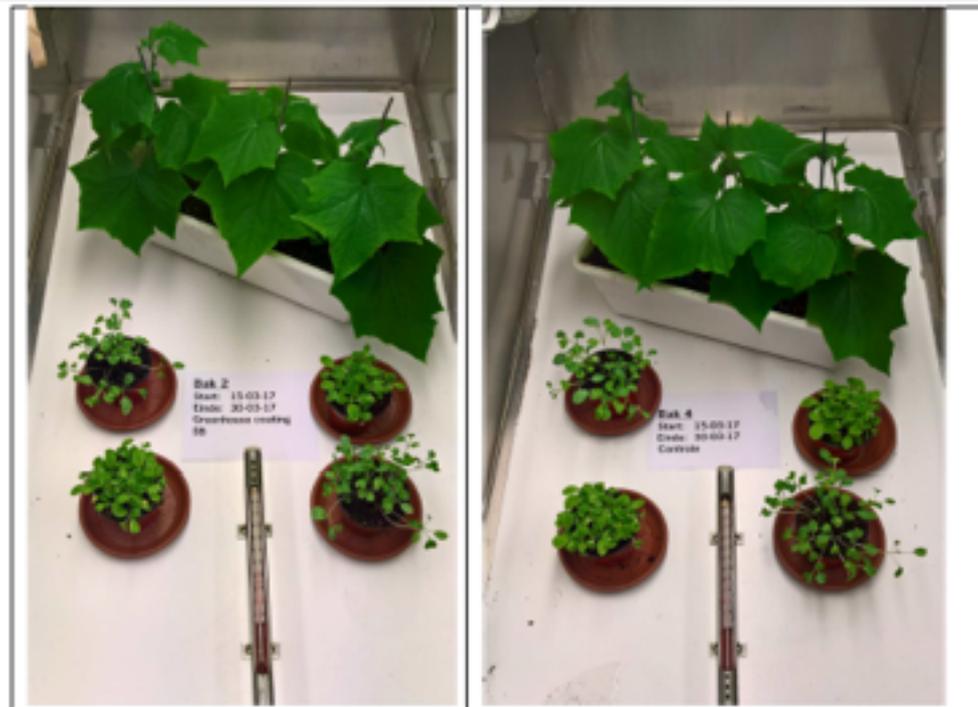
During the 15-day test with the coated samples, no abnormalities were observed in any of the crops tested in terms of growth or any discoloration caused by the coating used (see photos).

Photos taken on 30-Mar-2017. Left: photo of plants that were aerated with greenhouse coating PIPE PAINT H51 SB. Right: control treatment without the coating.
