WUR GREENHOUSE HORTICULTURE INSPECTION REPORT

Test number: 2017-905
Subject: Pipe paint coating
Type: PIPE PAINT H53 WB
Submitted by: Mr G. Geraerts, Spuiterij Geraerts, Ambachten 10, 5711LC Someren (NL)

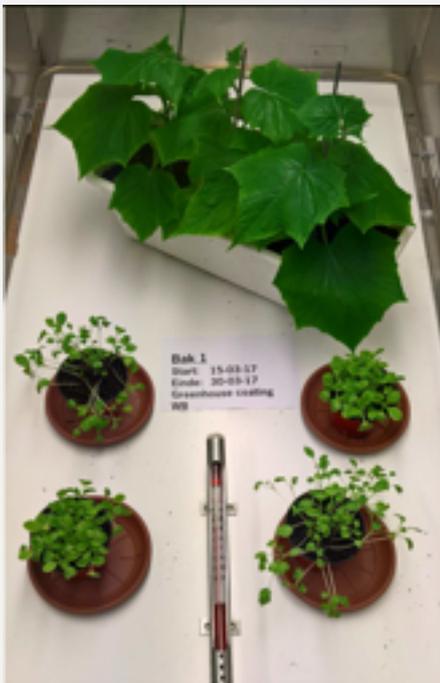
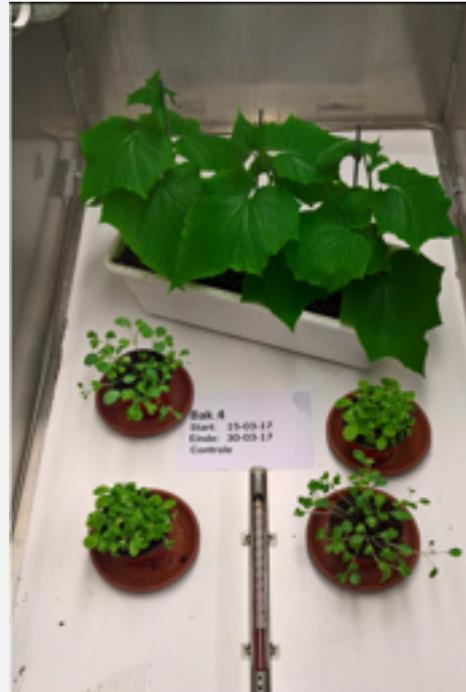
During the 15-day test with the coated samples, no abnormalities were observed in any of the crops tested in terms of growth or any discoloration caused by the coating used (see photos).

Photos taken on 30-Mar-2017. Left: photo of plants that were aerated with greenhouse coating PIPE PAINT H53 WB. Right: control treatment without the coating.
